## Afghan International Journal of Science

### Assessment of Erosion Influence on Asphalt Pavement of Kabul-Kandahar Highway

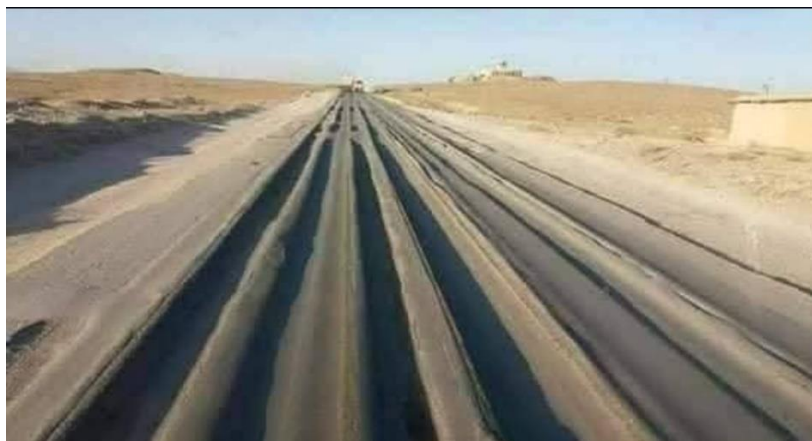
*Figure 1. Deterioration of the Kabul-Kandahar highway (Google, 2019)*

Given the strategic importance of the Kabul–Kandahar Highway as Afghanistan's primary national strip, understanding the instruments of erosion-induced asphalt deterioration along this route is essential. The interaction between climatic stressors, traffic loading, and material performance makes this highway particularly vulnerable to erosion-related pavement failures. Therefore, this study emphasizes analyzing erosion impacts along the Kabul–Kandahar Highway to support evidence-based maintenance and design decisions (Al-Atroush et al., 2022). The focus and targeted area of this research is the beginning and initial section of the Kabul-Kandahar highway, where unexpected weather conditions, including heavy rainfall, climate change, snow, freezing temperatures in winter, though various forms of asphalt pavements deterioration, such as Settlements, Potholes, Rutting, Fatigue cracks, Edge cracks, Block cracks, Reflection cracking and other types of surface degradation. Meanwhile, it should be noted that asphalt erosion refers to the deterioration, decay, and reduction in the quality of asphalt roads and streets, leading to surface irregularities and ultimately reducing vehicle safety (Bomers and Aguilar, 2018). The main causes of asphalt erosion are a mix of mechanical and environmental factors. Frequent traffic loading speeds up surface deterioration and adds to structural fatigue, particularly from heavier vehicles (Bukhari et al., 2023). Moreover, inadequate drainage systems can allow water to seep into pavement layers, eroding the subgrade and lowering the asphalt's structural integrity (Aursand et al., 2013). Temperature variations, especially freeze-thaw cycles throughout the winter, cause the pavement to expand and contract, which can lead to layer separation and cracking. The rate of erosion is further increased by Low-quality materials and incorrect construction methods, leaving the asphalt more susceptible to premature deterioration (Ahmad & Khawaja, 2018).

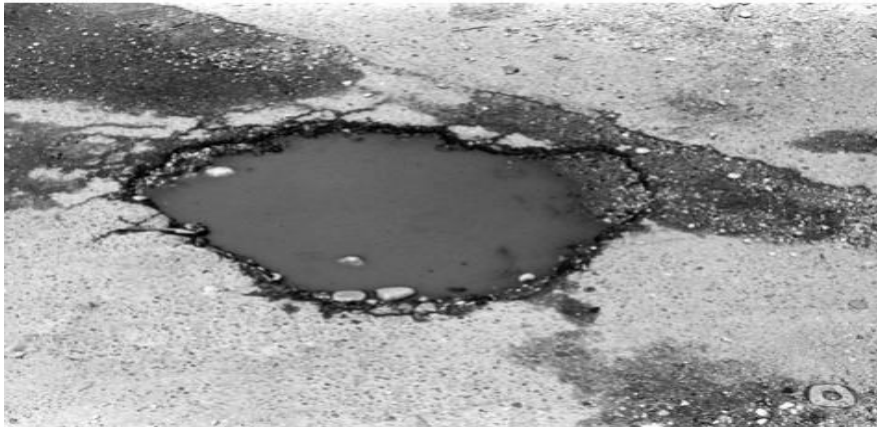
Potholes are mostly caused by water seeping into the pavement layers, which are repeatedly compressed by passing vehicles (Qiu et al., 2025). Surface depressions or cavities eventually form as a result of this process, which erodes the road surface's structural integrity. One of the main causes of asphalt pavement degradation is moisture infiltration. When water percolates through surface fissures and accumulates under the top layer, it reduces the materials' ability to bind and weakens the base's ability to support weight (Sapora et al., 2014). Freeze-thaw cycles, which produce expansion and contraction within the pavement structure, frequently accelerate this process in cold climates. Furthermore, pavement failure is exacerbated by dynamic loads from heavy traffic, as well as by environmental factors (Wang et al., 2021).

*Figure 2. Potholes deterioration (Ahmad & Khawaja, 2018).*

Frequent vehicle stress, particularly from trucks and buses, accelerates the deterioration of weak areas, transforming small surface defects into large depressions. Moreover, if these defects are not addressed promptly through maintenance, they may spread rapidly over time, endangering public safety and increasing repair costs (Tang et al., 2024). Pothole formation can be prevented by using high-quality construction materials and proper road design. Water-resistant layers, such as waterproof membranes, and surface treatments that prevent cracking can greatly extend pavement lifespan (Ahmad & Khawaja, 2018).

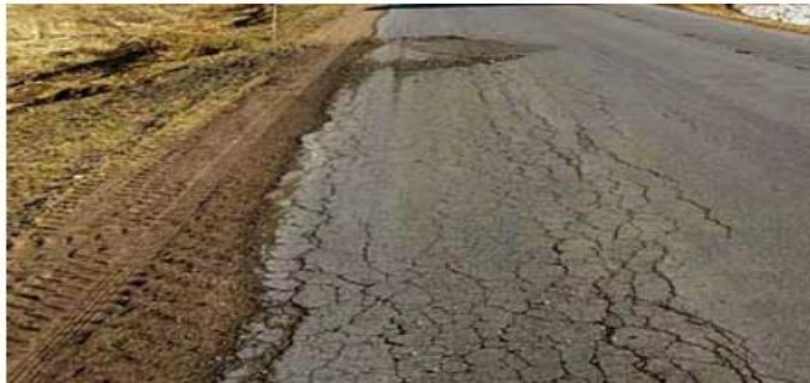
Edge cracks, as seen in Figure 3, are frequently observed in cold locations. These cracks usually appear as long, arching fractures along the pavement margins. They are a combination of alligator and longitudinal cracking patterns that develop near the pavement's shoulder (Wei et al., 2022). The main causes of edge cracks are poor drainage, insufficient lateral support, and heat contraction. The deterioration process is accelerated when moisture infiltrates these fractures, particularly with frequent traffic loading and freeze-thaw cycles (Yan et al., 2024).

*Figure 3. Edge cracks: Deterioration (Chai et al., 2023)*

If left unrepaired, edge cracks can spread and cause major structural damage, necessitating costly repairs. Several preventative measures should be considered during the design and maintenance stages to avoid edge cracks. These include using temperature-resistant materials that can better withstand thermal changes, enhancing drainage systems to prevent water accumulation, and ensuring that the pavement edge is properly supported by adequate shoulder

Differential settlement between the pavement and the shoulder is a primary contributing factor to edge cracking (Chai et al., 2023). The shoulder may settle faster than the adjacent pavement if it is made of weaker or non-compacted materials. This vertical offset creates stress concentrations along the pavement edge, leading to the initiation and propagation of cracks.

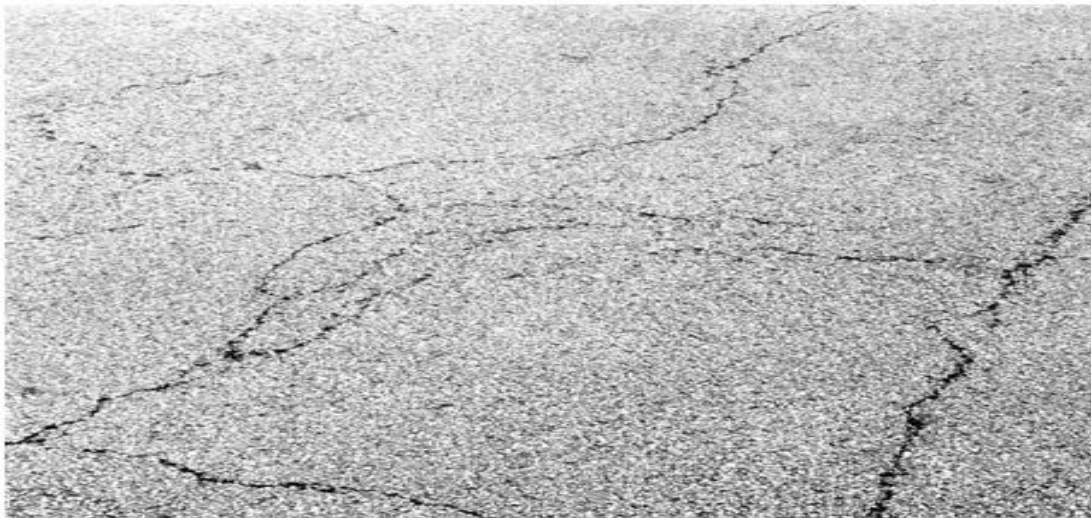
Block cracks, as seen in Figure 4, are evident as interconnected rectangular fragments.

*Figure 4. Block cracks Deterioration (Bukhari & Aman, 2023)*

The block cracks, which vary in size from roughly 0.1 m<sup>2</sup> to 12 m<sup>2</sup>, allow water to leak through. Furthermore, these fractures are frequently observed in pavements with overly dry or aged asphalt mixes containing absorptive particles. They usually arise from the gradual shrinking of the asphalt binder, especially in the presence of temperature changes and extended oxidation. Block cracks, in contrast to fatigue cracking, are a sign of aging and environmental degradation rather than being directly related to traffic loading. Moreover, a suitable asphalt mix design

with optimal binder content and good workability is essential for preventing block cracking (Wei et al., 2022). The aging process can be slowed by using anti-oxidation additives and timely surface treatments such as fog seals, rejuvenators, or seal coatings. Routine inspection and preventive maintenance enable early detection of block cracking, allowing quick interventions before serious degradation occurs. To lower the risk of block crack development during construction, it is also critical to ensure proper compaction and to avoid excessively dry mixtures. Inadequate compaction during pavement construction is another cause of block cracking (Bukhari & Aman, 2023).

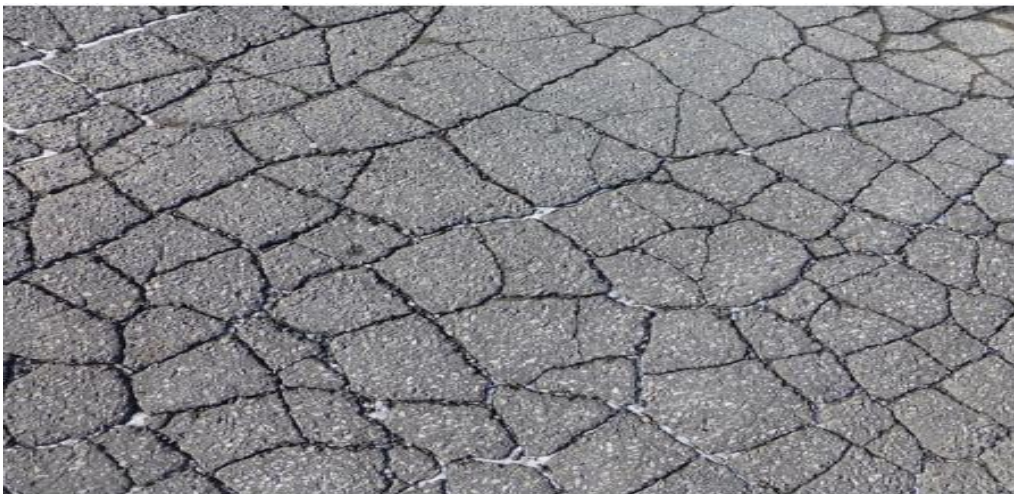
Fatigue cracks are among the most common and severe forms of distress observed in asphalt pavements. These cracks usually appear due to cyclic tensile strains in the asphalt layer caused by frequent traffic loading. Over time, these forces accumulate, leading to fractures that initiate and spread, particularly in areas with weak pavement structures or inadequate subgrade support. The term "alligator cracking" is often used because this type of cracking typically forms a patterned network of interconnected, sharply angled segments that resemble an alligator's skin (Zhang et al., 2020). These cracks generally occur in areas experiencing high traffic loads, such as wheel paths, and are typically less than 0.3 meters long on their longest side. Fatigue cracks create complex geometries that indicate significant pavement structural failure, as seen in Figure 5.

*Figure 5. Shows Fatigue cracks and Deterioration (Ahmad & Khawaja, 2018)*

Moreover, fatigue cracking can be caused by several factors, including moisture, aging of the asphalt binder, insufficient pavement thickness, and poor construction practices. Once initiated, these fractures allow water to seep into the pavement, weakening the base and accelerating disintegration. If not treated promptly, fatigue cracks can develop into potholes, compromising traffic safety and increasing maintenance costs. To reduce the incidence and spread of fatigue-related damage in asphalt pavements, effective design strategies are crucial. These include the use of high-quality materials, appropriate layer thicknesses, and timely maintenance interventions such as crack sealing and surface treatments (Ahmad & Khawaja, 2018).

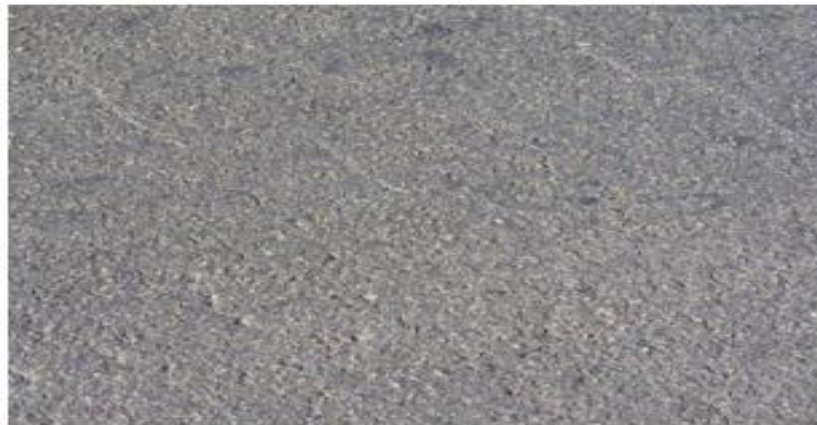
Figure 6. Asphalt with good skid resistance (Wang et al., 2024)

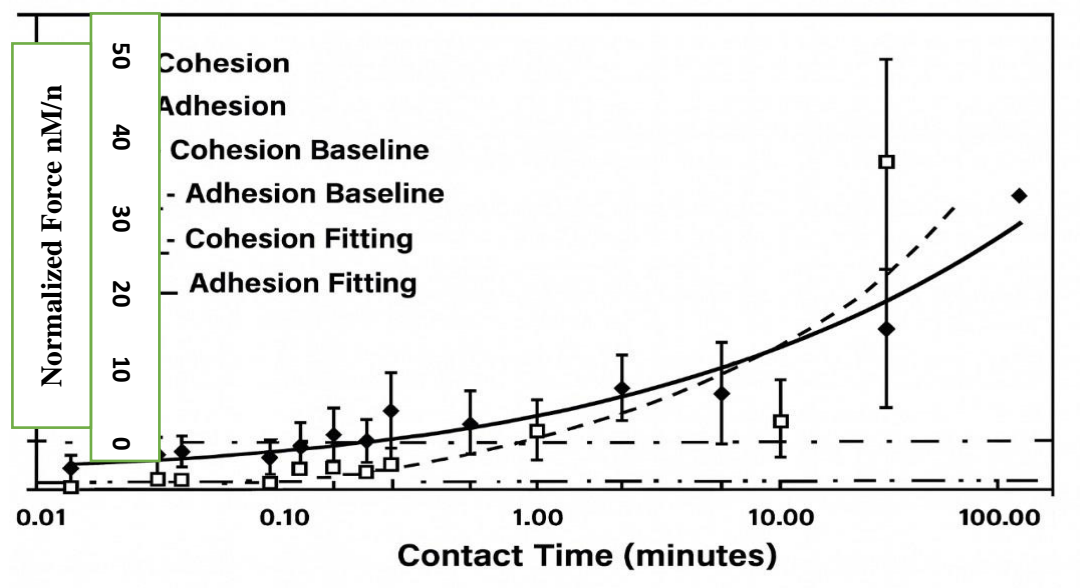
The asphalt film also helps distribute stresses more evenly by preventing structural separation. Moreover, asphalt film serves as a moisture barrier, preventing water from seeping into the lower pavement layers. This is especially crucial in regions where excessive rainfall or freeze-thaw cycles can cause potholes, rutting, fatigue, and subgrade weakness. The asphalt film's waterproofing enhances the road's overall durability (Long et al 2023).

Figure 7. Adhesive & Cohesive bonding (Nie et al., 2023).

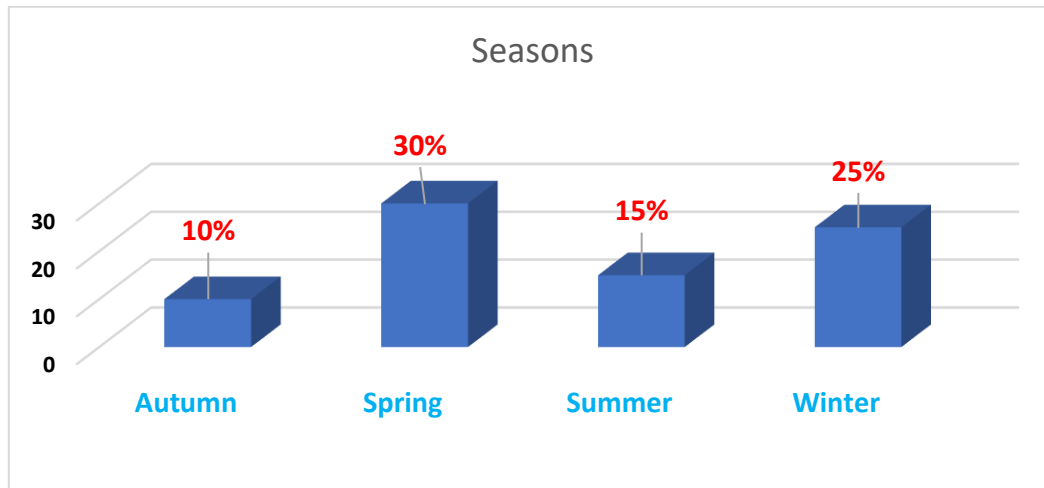
and limited snowfall. Rainfall is mainly confined to spring and autumn, with an average annual precipitation of approximately 300–400 mm. Although snowfall is not abundant, it can still affect traffic and road surface conditions during peak winter. Wind patterns are generally moderate, but dust-laden winds from surrounding barren areas may exacerbate surface erosion and reduce visibility, particularly in late summer. The combination of seasonal precipitation, freeze-thaw cycles, and sporadic flash floods contributes to pavement wear and structural vulnerability, making climate-responsive design and maintenance essential for this portion of the highway (Lu et al., 2023).

*Figure 8. Climatic Condition of precipitation (Lu et al., 2023)*

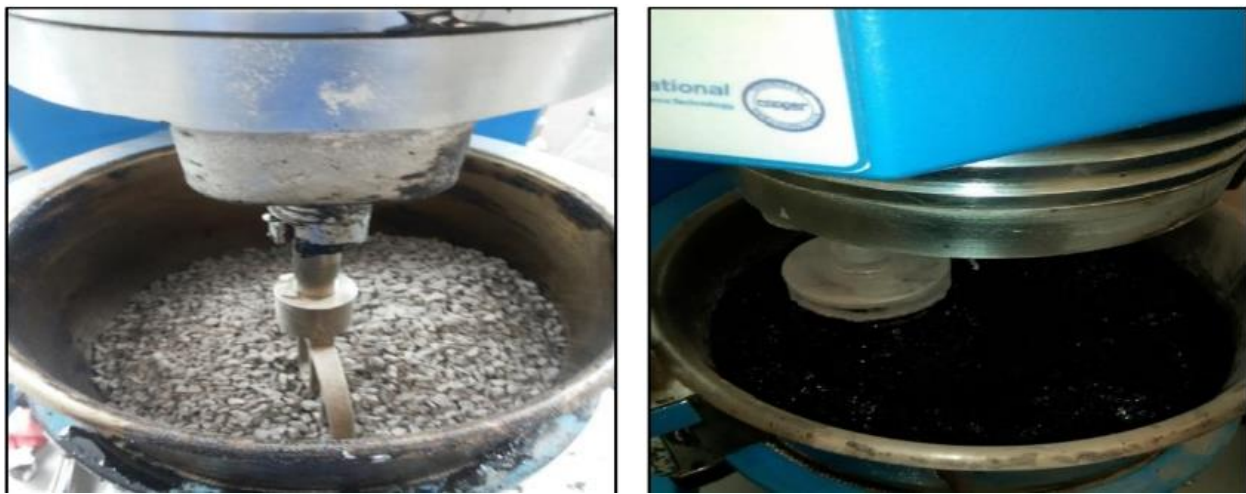
For this research, data analysis was carried out using Google Forms, based on a set of 22 specialized questions administered to highly experienced, professionally qualified engineers. The thorough mixing process below is essential for producing high-quality asphalt with adequate workability, durability, and mechanical performance suitable for road pavement construction. The entire mixing operation was carried out in accordance with BS EN 12697-35:2004 standards (British Standards Institution, 2004) to maintain stability and quality. The mixing duration and speed were adjusted based on the mixture's viscosity and aggregate characteristics, ensuring that all components were uniformly distributed without separation or excessive oxidation of the binder.

*Figure 9. Mixing of asphalt materials (Lu et al., 2023)*

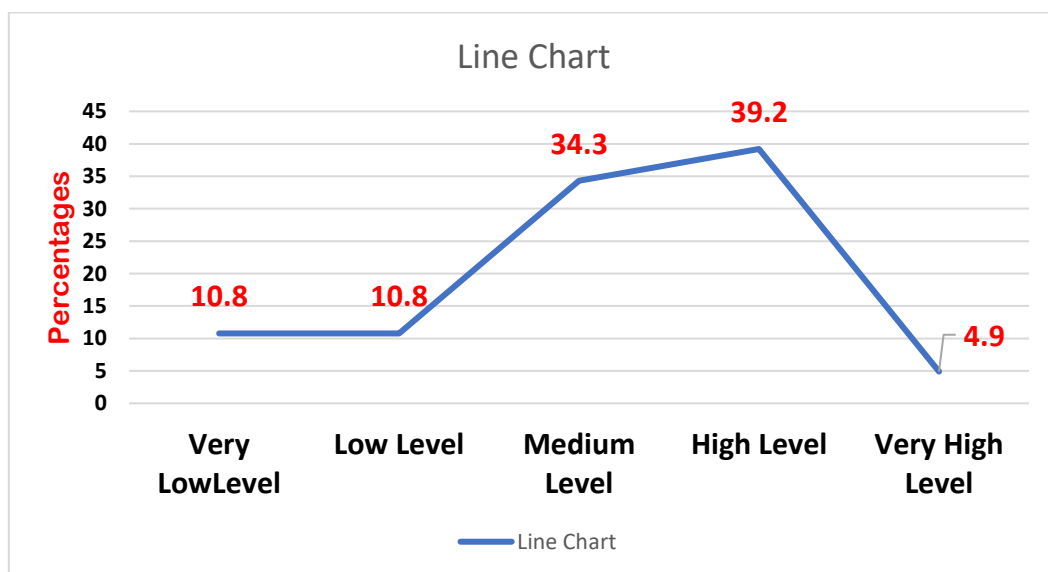
Figure 12 presents the professional assessment of 102 experienced engineers and infrastructure specialists on the current stage of erosion-related deterioration of the Kabul–Kandahar highway, one of Afghanistan's most vital national corridors.

Figure 12. Deterioration stage of Erosion on Kabul-Kandahar Road

The responses show clear concern among professionals: about 40 expert engineers (39.2% of respondents) selected "high level deterioration," indicating that erosion damage is already extensive and is seriously compromising the road's structural soundness and usability. This result demonstrates the critical need for corrective and preventive measures. An additional 34.3% of respondents reported a "medium level" of degradation, indicating that while the damage is not currently catastrophic, it is developing and could worsen rapidly without prompt reinforcement and maintenance. Approximately 10.8% of respondents (roughly 11 professionals) selected "low" or "very low" levels, suggesting that only a small percentage of road segments may still be in relatively stable condition or have recently undergone rehabilitation.

A smaller group (4.9%, or about 5 individuals) classified the erosion deterioration as "very high level," likely representing severely damaged areas that are either near failure or already nonfunctional. According to the distribution of responses, more than 70% of experts believe that the Kabul–Kandahar Road is experiencing medium to high, or very high, erosion. This is concerning for a national roadway that connects important population and economic centers. The range of deterioration levels also reflects variations in drainage capacity, environmental exposure, construction quality, and ongoing maintenance across different segments of the route. Furthermore, most professional engineers consider erosion deterioration along the Kabul–Kandahar Road to be at medium to high levels, indicating a national infrastructure risk that requires strategic action.

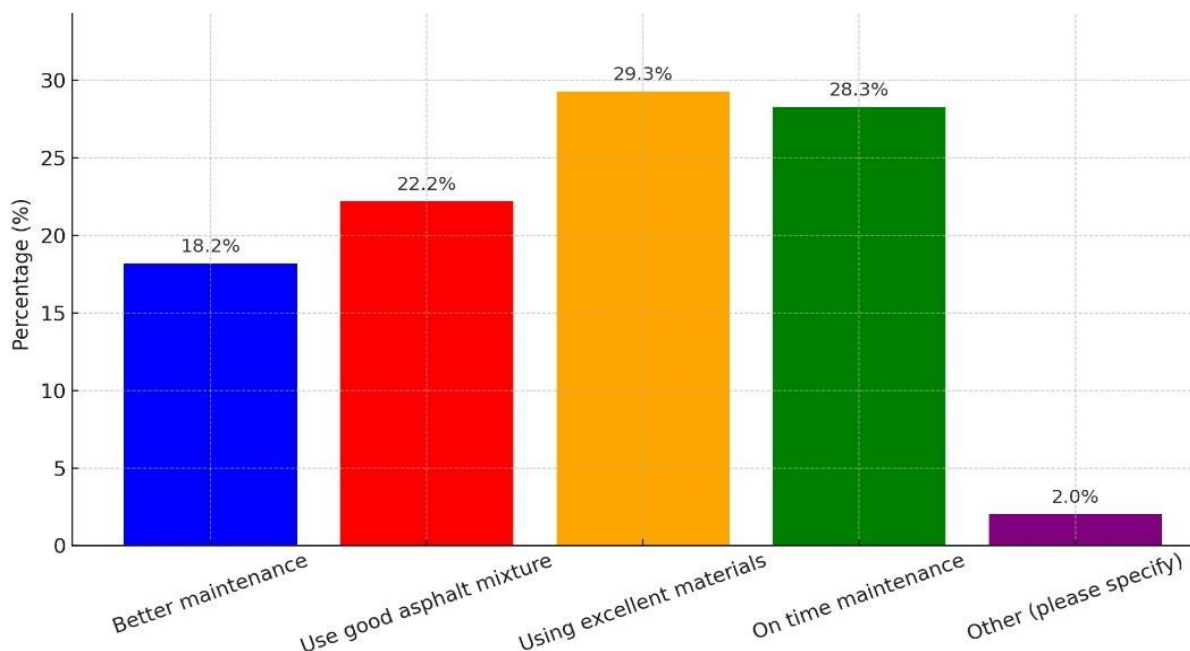
Responses from 103 experienced participants about the best strategies to prevent asphalt erosion from affecting pavement are shown in Figure 14. Of the respondents, 28.3% highlighted the significance of timely maintenance, while 29.3% emphasized the use of high-quality materials as the most important factor. Additionally, 18.2% cited the importance of improved maintenance procedures, and 22.2% believed that using high-quality asphalt mixtures could greatly reduce erosion. A small percentage, 2%, recommended different techniques under the category of "Others."

These results indicate that a significant proportion of experts identified the use of high-quality materials and timely maintenance as the best approaches, even though various strategies are considered beneficial. To effectively reduce the effects of erosion on asphalt pavements, greater attention and implementation should be focused on enhancing material quality and ensuring timely maintenance, as these two approaches were prioritized by the majority of experts.

**Figure 14:** Ways to prevent asphalt erosion impact on pavements
